# Light Inspections

## Home Inspection Report

Property Address:  
**4677 Horizon Rd  
Middleton, WI 53562**

Inspected on Fri, Aug 23 2019 at 1:00 PM

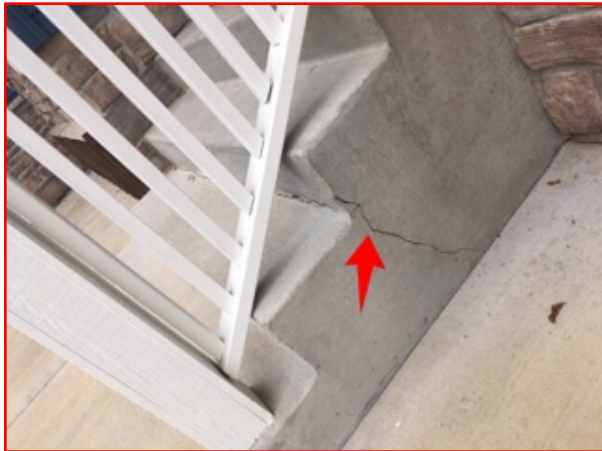
Figure 1-1

1) Comment 1: The front stoop stairs has settled causing a crack in concrete. Recommend sealing crack to prevent moisture intrusion leading to further damage. Also recommend monitoring this to determine if stair is still settling.

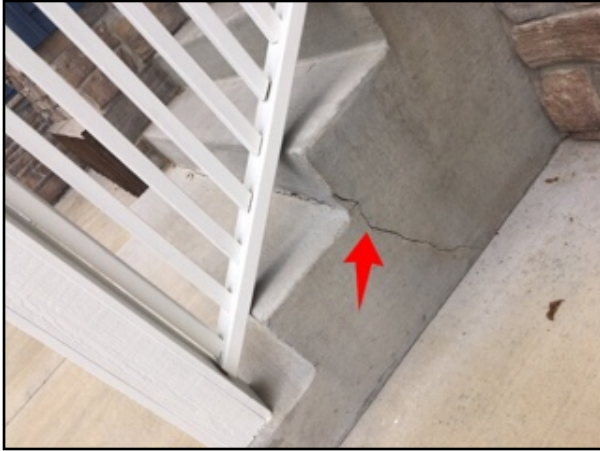
Figure 1-1

| Steps/Stoops: | Concrete<br>Condition: Repair or Replace |

The front stoop stairs has settled causing a crack in concrete. Recommend sealing crack to prevent moisture intrusion leading to further damage. Also recommend monitoring this to determine if stair is still settling.

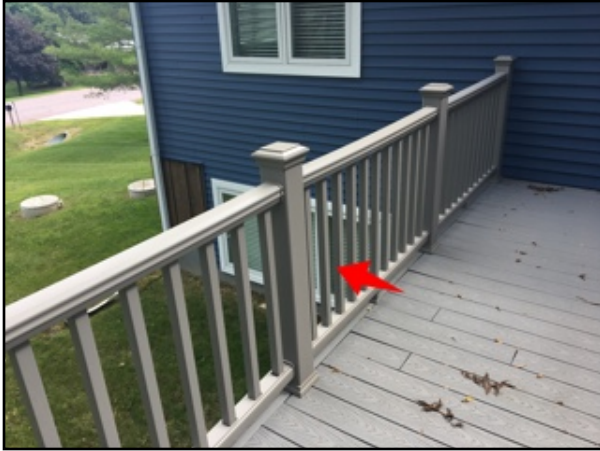
Figure 2-1

| Railings: | Composite<br>Condition: Repair or Replace |

Composite railings on deck are loose. Recommend re-tightening where needed so railings are able to properly support when pushed against.

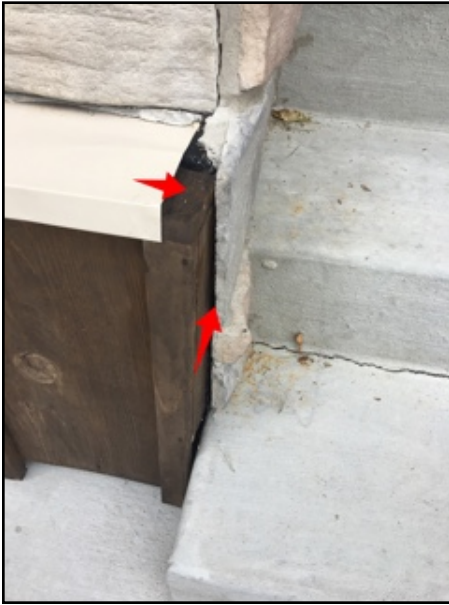
Figure 3-1

Comment 3:  
Recommend sealing edge of cultured stone with mortar or caulk to prevent moisture intrusion.

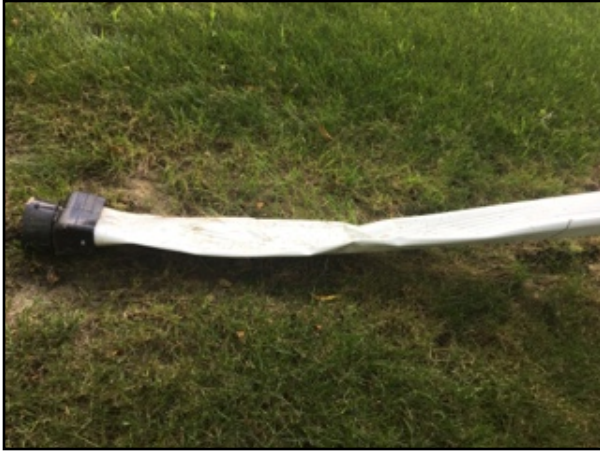
Figure 4-1

Backyard gutter downspout is crushed. Recommend replacing with new one.

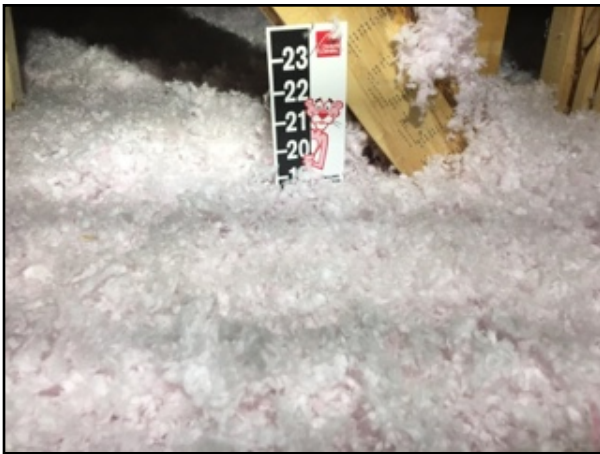
Figure 6-1

Average Insulation Depth=20"

R Value =49.

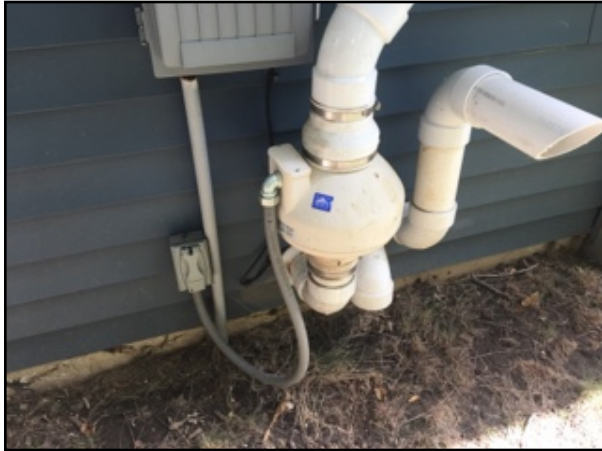
Figure 10-1

Radon mitigation system installed in home. Recommend having radon tested periodically to make sure system is properly functioning.
